*The following is a description of a project at a large Canadian hospital utilizing coatings manufactured by Safe Encasement Systems.*

## **Encasing Asbestos Fireproofing at a Major Canadian Hospital**

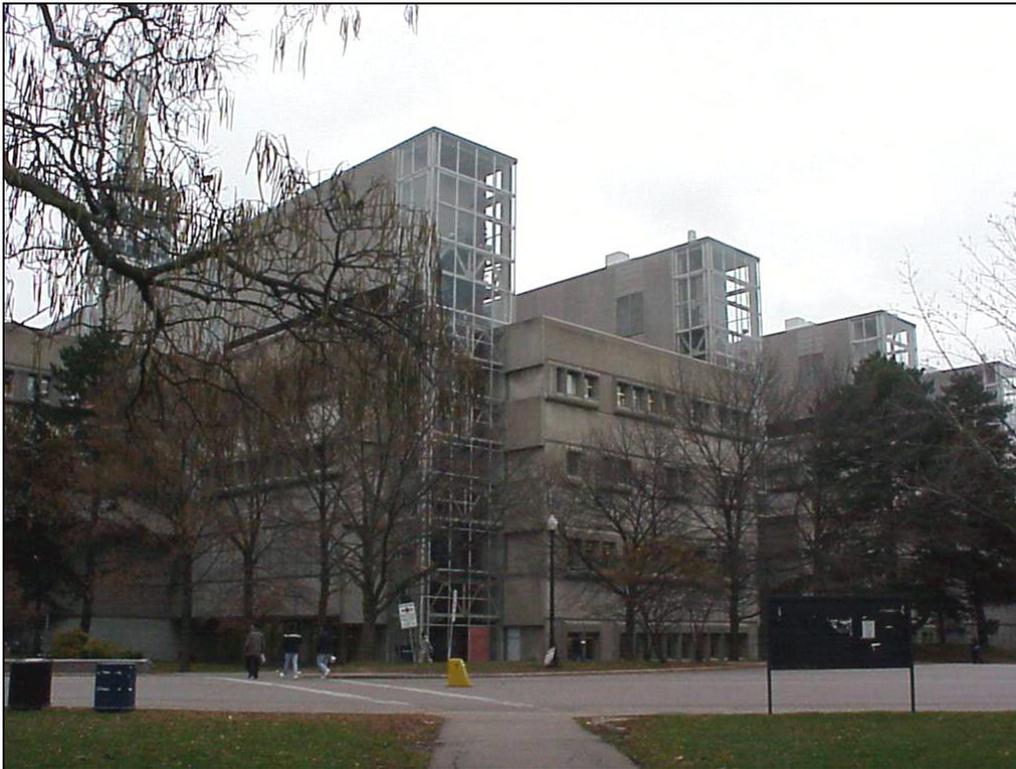
MUMC is essentially a ten story-high structure comprised of four clinical floors, four full story “interstitial floor” (one located above each clinical floor), and two floors of mechanical penthouses (PHOTO 1). The basic footprint for the first eight stories is approximately 250,000 square feet, with the penthouses being about 125,000 square feet.

Pictured above is front of Health Care Building (top) and fireproofing before encasement (lower).

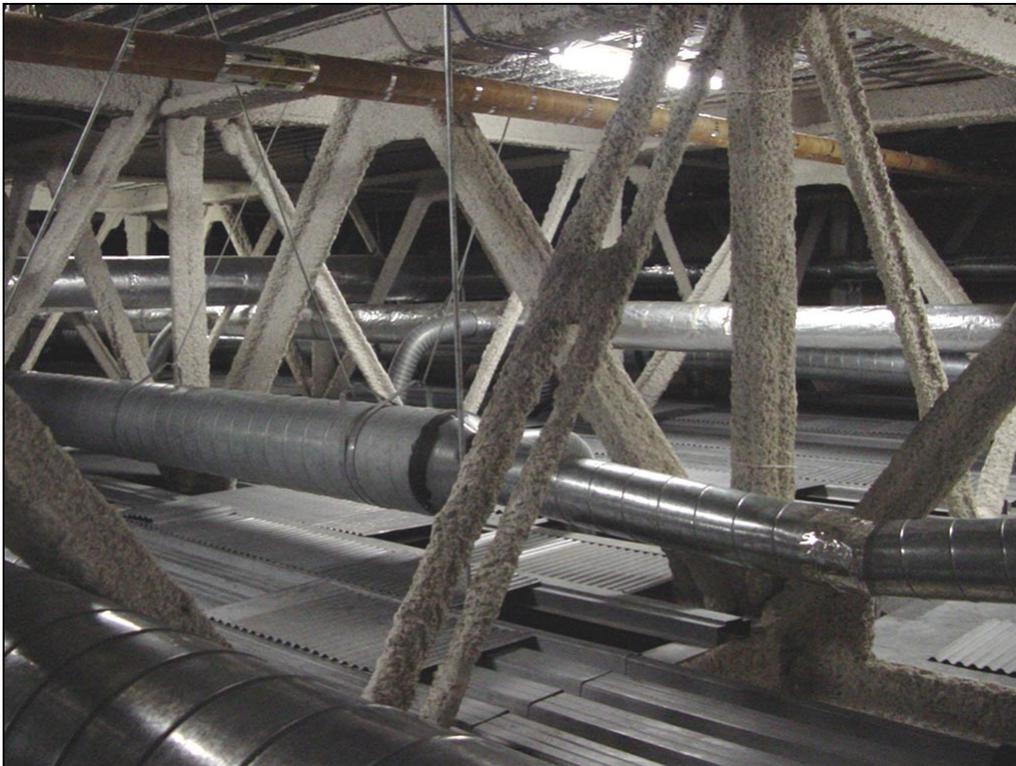
As was typical of steel superstructure buildings constructed in the early 1970s, a sprayed-on cementitious fireproofing containing 10% to 15% chrysotile asbestos was applied to all of the structural steel (PHOTO 2). This is a rigid material, and is susceptible to age-related cracking, and displacement when subjected to impact. Fallen dislodged fragments can be crumbled or crushed to a powder.

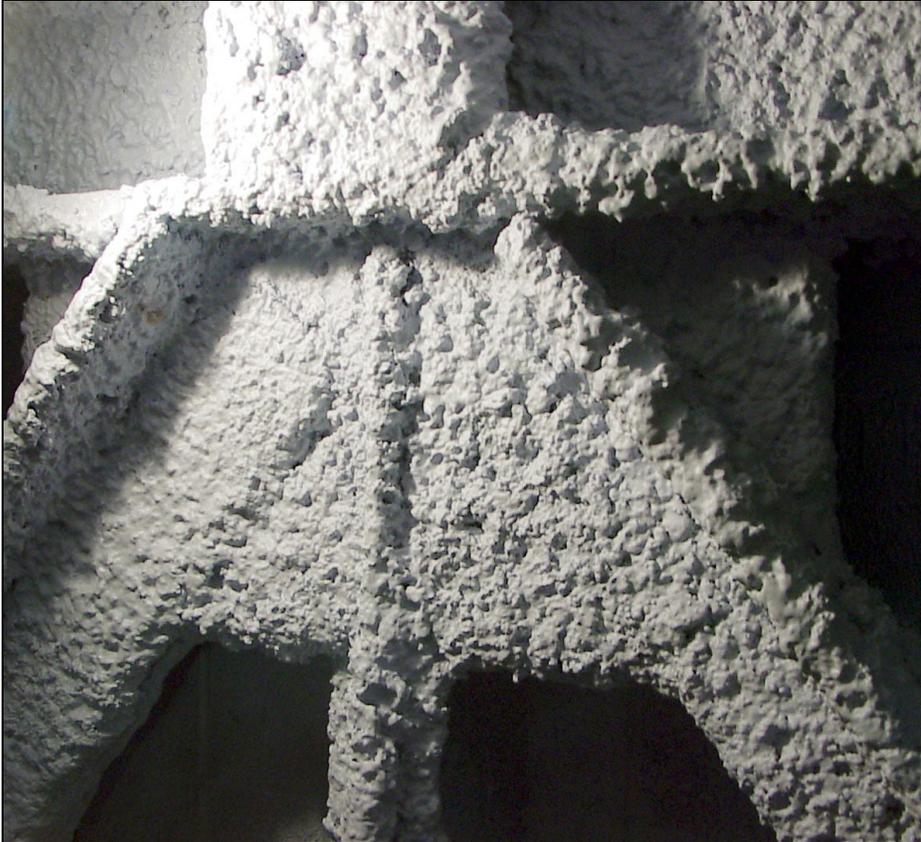
Pictured below is a close-up of encasement (top) and a view of the structural steel after encasement (below).
